# Western Downs 275 kV No. 2 Busbar Trip on 22 March 2021

**July 2021**

Reviewable Operating Incident Report under the  
National Electricity Rules

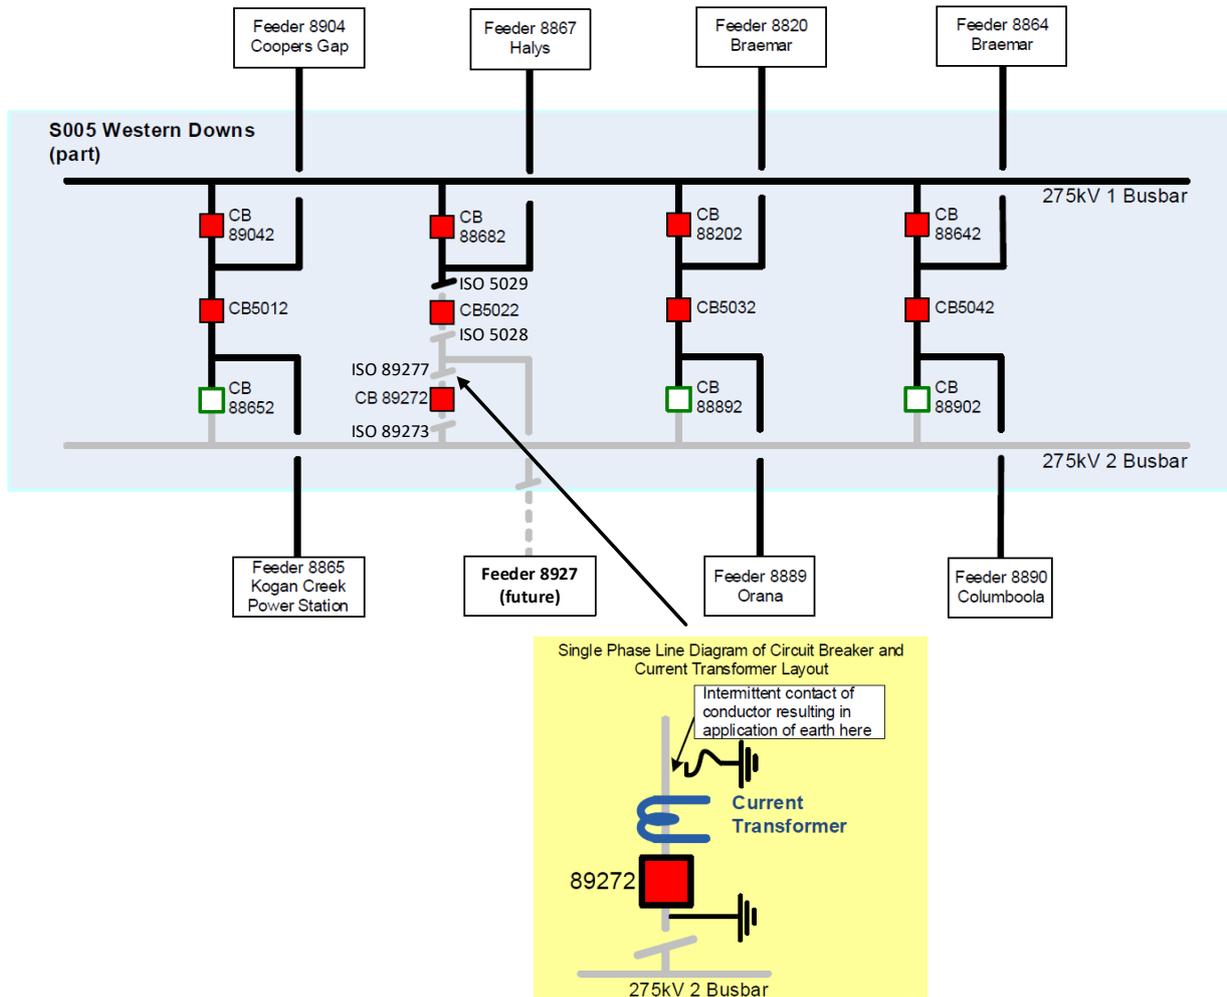
<b>Key events</b>	<ol style="list-style-type: none"> <li>1- At 1147 hrs on 22 March 2021, the Western Downs No. 2 Busbar protection operated, causing all of the in service closed circuit breakers on the No. 2 Busbar to trip.</li> <li>2- The Western Down No. 2 Busbar was returned to service at 1301 hrs on 22 March 2021.</li> </ol>
<b>Incident cause</b>	Induced circulating current in the current transformer (CT) of CB89272 resulted in No. 2 Busbar protection operation and subsequently the trip of Western Downs No. 2 Busbar.
<b>Power system response (facilities and services)</b>	<p>As part of planned maintenance works, high voltage conductors had been removed from the VT side of ISO89277 and earthed. These removed conductors were tied back towards the CB89272 side of ISO89277. CB89272 and its associated CTs were out of service and isolated only on the primary side.</p> <p>Wind caused an intermittent contact to be formed between one of the removed high voltage conductors and the CB89272 side of ISO89277. As a result, a closed loop between the earth grid and the high voltage conductors was created. Due to CB89272's proximity to in-service high voltage equipment, an induced current flowed around this closed loop and through the CTs of CB89272. The induced current was sufficient to operate the No. 2 Busbar protection.</p> <p>The No. 2 Busbar protection operated as expected according to design and opened all in-service closed circuit breakers on the No. 2 Busbar. CB89272 remained closed because its trip circuits had been isolated as part of planned works, however ISO89277 was open as noted above. Refer to Figure 1 for the configuration at the Western Downs substation after the incident.</p>

Details
	Powerlink advised that the CTs were not isolated from the secondary side, because the planned maintenance works did not involve any activity on CB89272 which could cause circulating current through its associated CTs. Powerlink's standard process requires isolation of the secondary side of the CTs only if the planned work involves any activities where circulating currents are considered possible.
<b>Rectification and/or preventative procedure</b>	Powerlink advised that additional precautions (including repositioning the tied back conductors) were implemented for the rest of this maintenance task to avoid the risk of creating an intermittent conductive path via the earth grid and the CTs of CB89272.
<b>Power system security</b>	The power system remained in a secure operating state throughout this incident
<b>Reclassification</b>	AEMO assessed whether to reclassify this incident as a credible contingency event <sup>3</sup> . Powerlink advised AEMO that the cause of the trip of the Western Downs No. 2 Busbar had been identified and the incident was unlikely to reoccur. Based on this advice, AEMO correctly determined the incident was unlikely to reoccur and therefore correctly determined that reclassification as a credible contingency event was not required.

**Figure 1** The configuration at the Western Downs substation after the incident including the intermittent conductive path through the current transformers of CB89272

<b>Recommendations</b>	AEMO will share details of this event with Transmission Network Service Providers at Power System Security Working Group and Operational Planning Working Group meetings in Q3 2021 to enable them to consider any implications for maintenance practices.
