Trip of Bell Bay No. 3 and No. 4 Potlines on 1 January 2022

June 2022

Reviewable Operating Incident
Report under the National
Electricity Rules

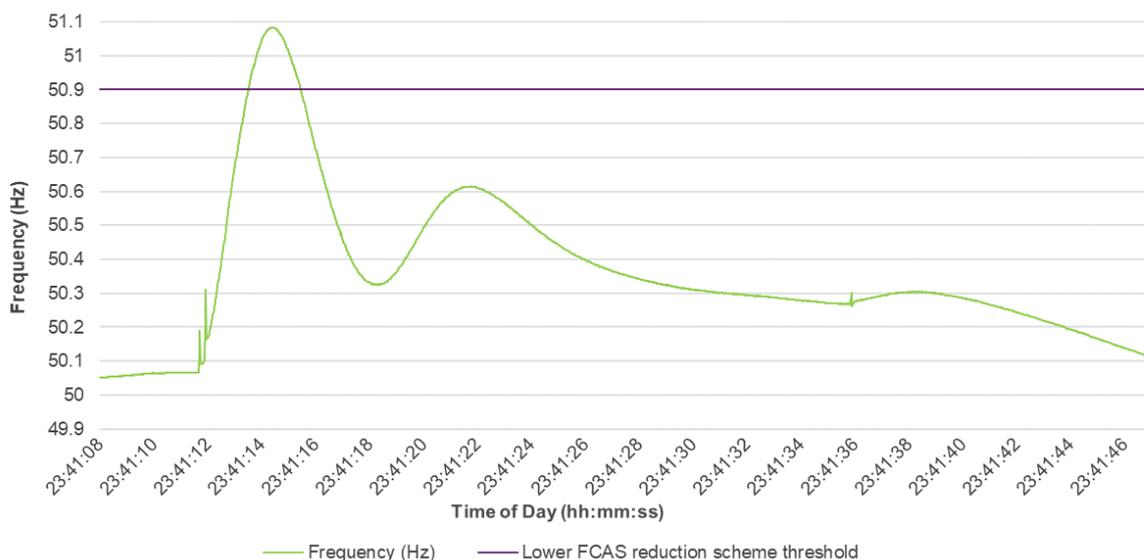
Figure 1 Tasmania frequency response during the incident on 1 January 2022

Power system response (facilities and services)	At 2341 hrs on 1 January 2022, immediately after the trip of Bell Bay Aluminium No. 3 and No. 4 potlines, the frequency in Tasmania increased above 50.90 Hz (see Figure 1). This caused the Tasmania lower FCAS reduction scheme to operate and trip the Wayatina No. 1 generator. The frequency returned to 50.15 Hz 30 seconds after the operation of the Tasmania lower FCAS reduction scheme, which operated in line with its expected performance.
