Loss of SCADA and line protection at Keilor Terminal Station on 29 June 2023

April 2024

Reviewable operating incident
report under the National Electricity
Rules

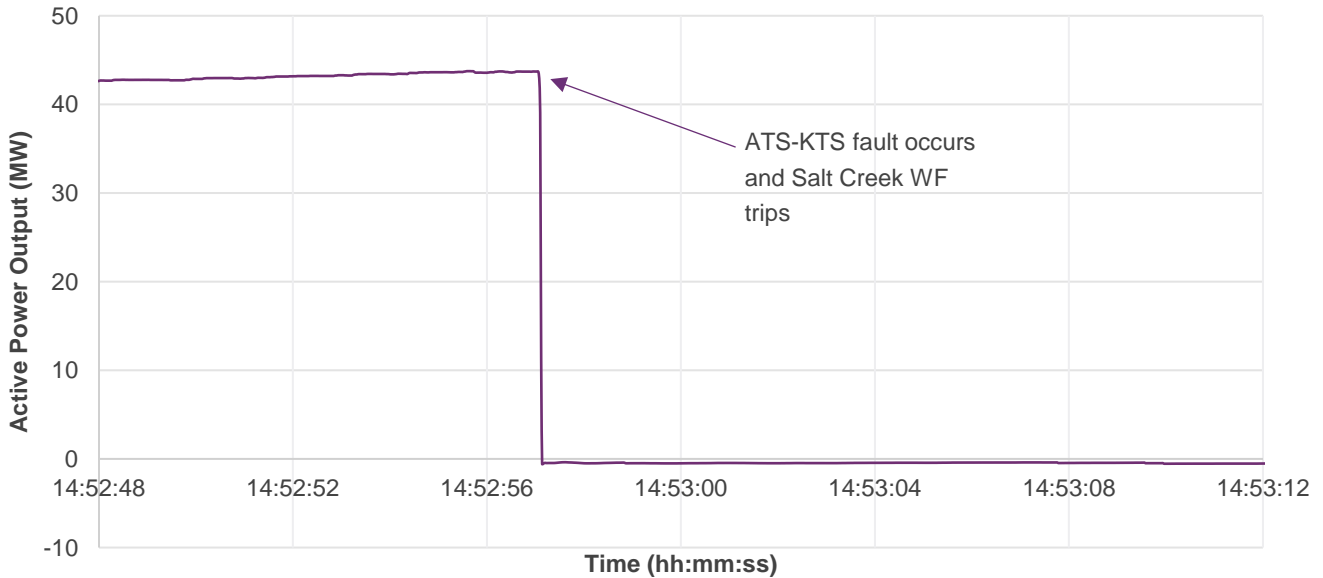
Figure 1 Salt Creek Wind Farm active power output on 29 June 2023

The SCWF unexpectedly tripped from 44 MW at 1452.57 hrs on 29 June 2023 following the fault on the ATS – KTS 220 kV line. Following review of the incident, Tilt Renewables has advised AEMO that the cause of the trip was due to an incorrect control parameter setting. The units of the parameter were originally in amperes; however, a software update caused the units to be changed to per unit (p.u.). Tilt Renewables corrected the parameter in consultation with AEMO on 30 August 2023.

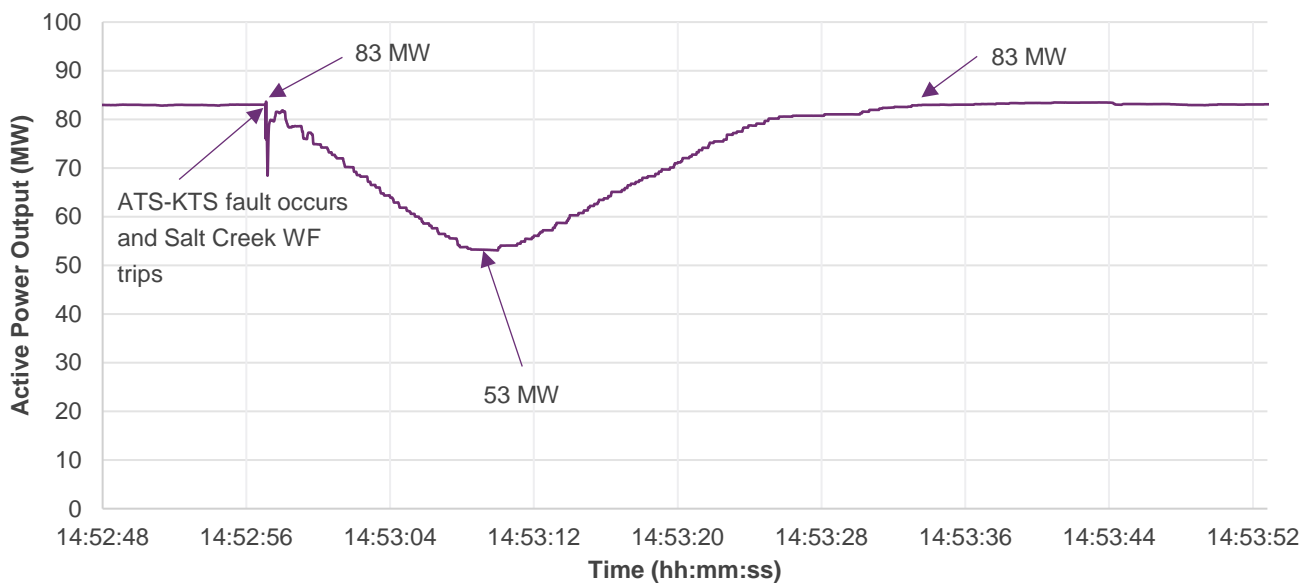
Figure 2 Mortlake South wind farm active power on 29 June 2023

The Mortlake South WF unexpectedly reduced output at 1452.57 hrs from 83 MW to 53 MW over a 13 second period. The Mortlake South WF subsequently increased output over the next 24 seconds to return to 83 MW. Figure 2 shows the active power output of the generator as recorded by high speed monitors. Acciona has confirmed that the generation reduction during this event was caused by a fault ride through settings issue. Acciona corrected the fault ride through settings issue on 19 December 2023.

This event highlights the potential for incorrect settings or unexpected performance to exacerbate disturbance events. To raise industry awareness of the need for all generators to ensure settings changes are appropriately

managed, AEMO plans to share this finding and relevant details with all NEM generators by the end of Q2 2024. AEMO will consider this and other incidents in its annual review of power system incidents and may identify further recommendations.

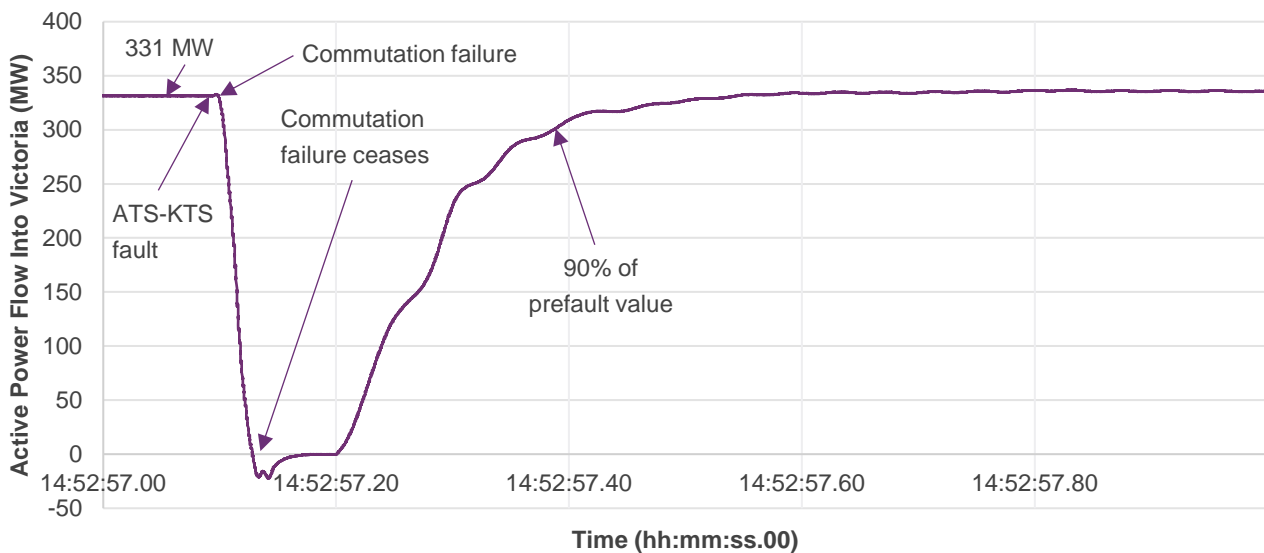
Figure 3 Basslink power flow to Victoria on 29 June 2023

At the time of the ATS – KTS 220 kV line fault, Basslink was exporting 331 MW to Victoria with a target of 320 MW. Figure 3 below shows commutation failure starts at 14:52:57.09. Flow on Basslink during commutation failure ceases and recommences after 115 ms increasing to 90% of pre-fault power flow within 300 ms.

As shown above, Basslink experienced commutation failure and successfully rode through the fault disturbance without tripping.

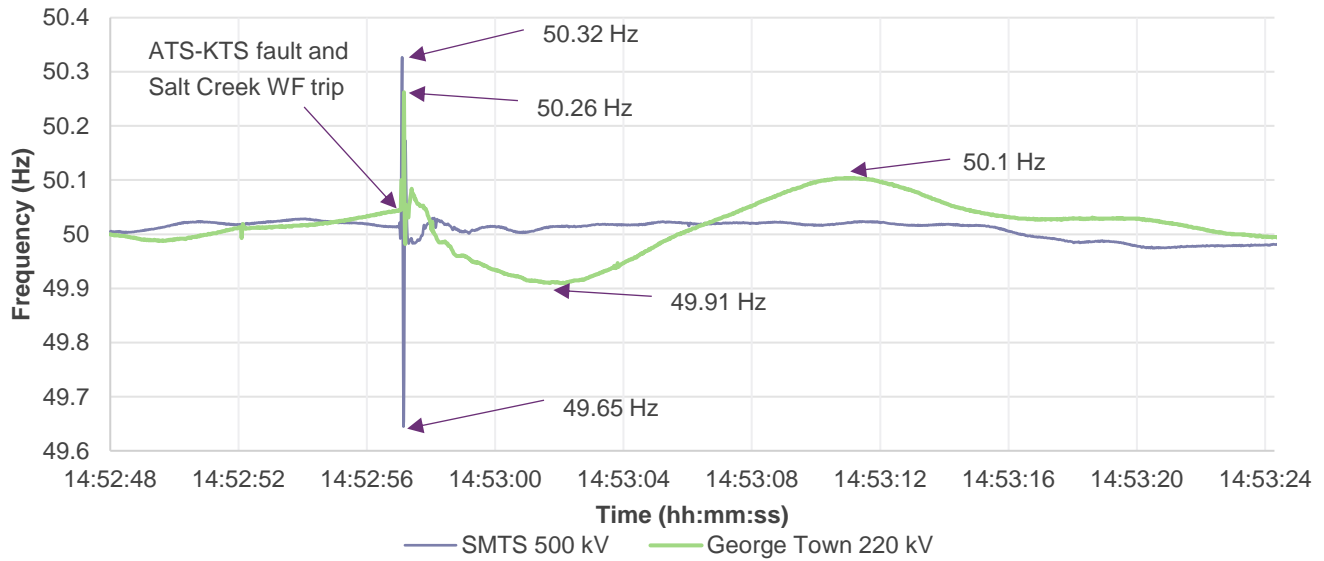
Figure 4 Frequency as recorded by phasor measurement units (PMUs) on 29 June 2023

Following clearance of the fault, frequency at SMTS returned to normal frequency ranges. Post-fault frequency at George Town had damped oscillations with a minimum frequency of 49.91 Hz and a maximum frequency of 50.1 Hz. The Frequency Operating Standard (FOS)³² was met for this incident.

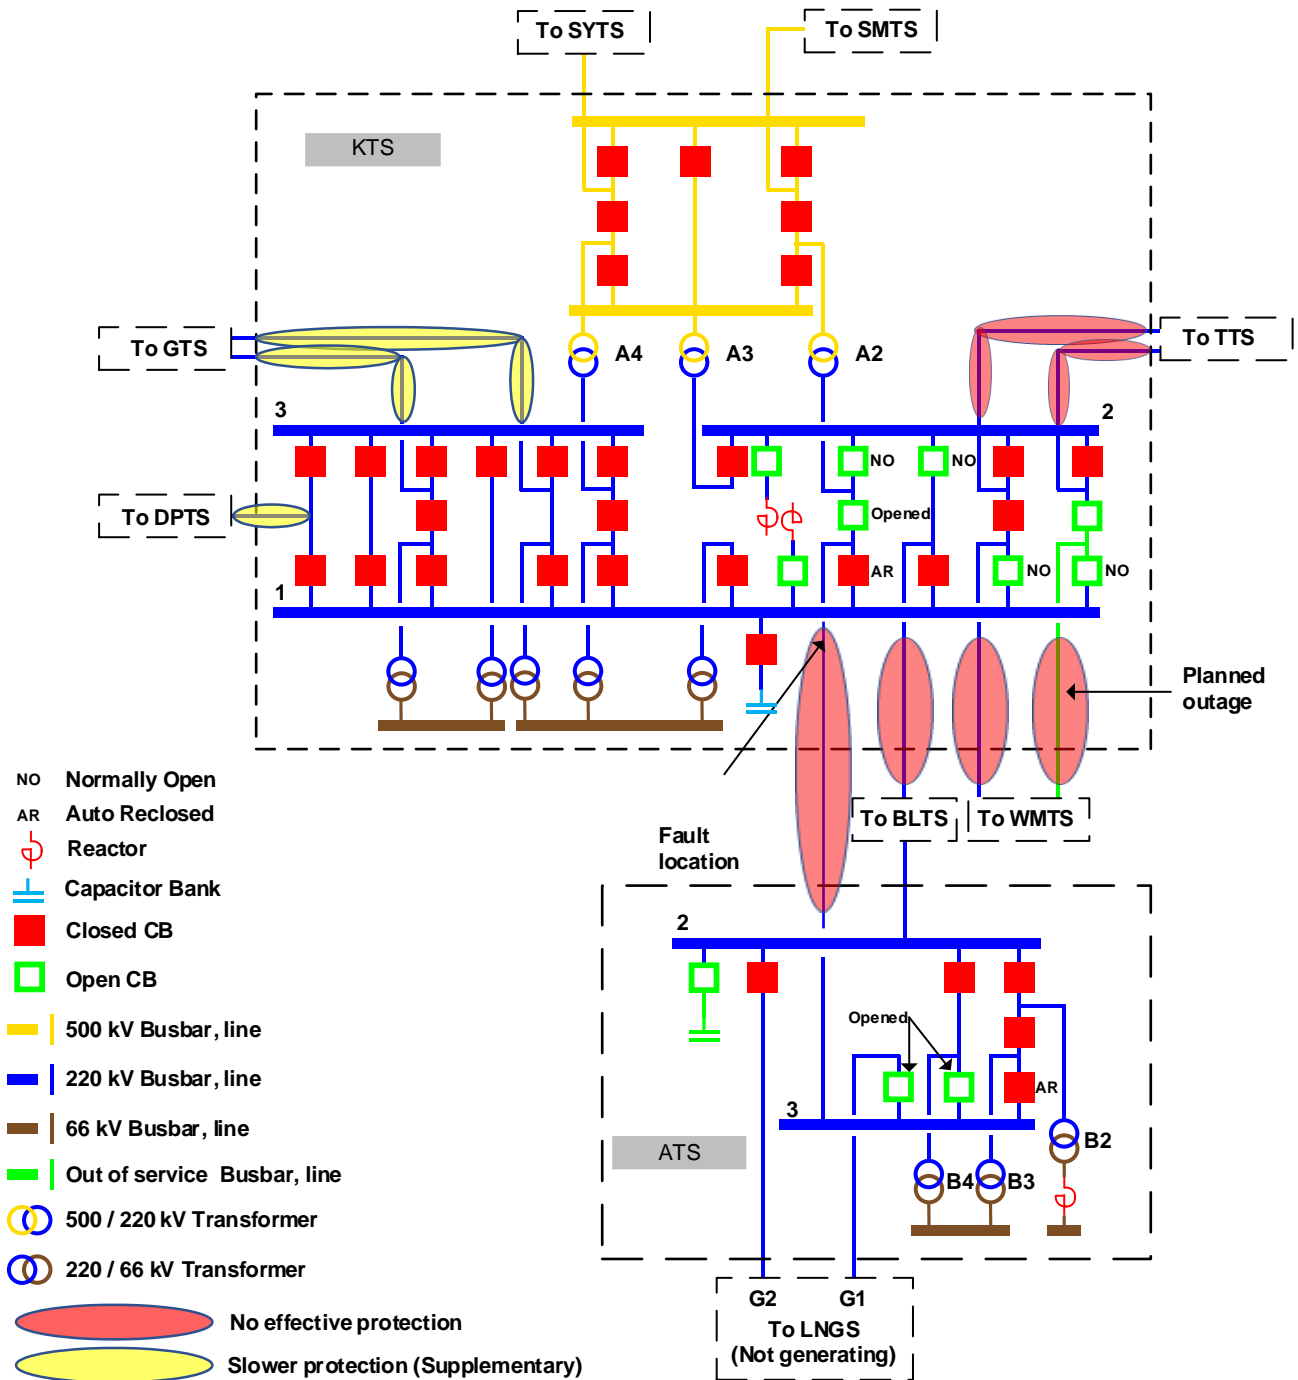
Figure 6 Network configuration after auto-reclosure

At approximately 1452 hrs on 29 June 2023, due to a fault on the ATS – KTS 220 kV line near KTS, the ATS – KTS 220 kV line tripped and auto-reclosed. As only one CB at each of ATS and KTS is set to auto-reclose, the KTS 500/220 kV A2 transformer was offloaded at the 220 kV side and the ATS – Laverton North Gas Station (LNGS) 220 kV No. 1 line and LNGS No. 1 transformer were disconnected. The disturbance from the fault was experienced throughout Victoria and in Tasmania via the Basslink DC interconnector. Salt Creek Wind Farm (SCWF) tripped from 44 MW and Mortlake South Wind Farm (WF) reduced power output from 83 MW to 53 MW over 13 seconds and returned to 83 MW over the next 24 seconds. A diagram of the post-incident network configuration is shown in Figure 6 of Appendix A1.

At KTS, auto-reclose of the ATS line is achieved by reclosing the ATS line No. 1 busbar 220 kV CB only. The ATS line/A2 transformer 220 kV CB remained open as per design. This resulted in the KTS 500/220 kV A2 transformer remaining energised via its 500 kV side but offload (as the 220 kV CB remained open).
