# POWER SYSTEM INCIDENT REPORT TRIP OF HAZELWOOD POWER STATION UNITS 1 AND 2 ON 9 JAN 2011

PREPARED BY: Electricity System Operations Planning and Performance

FINAL

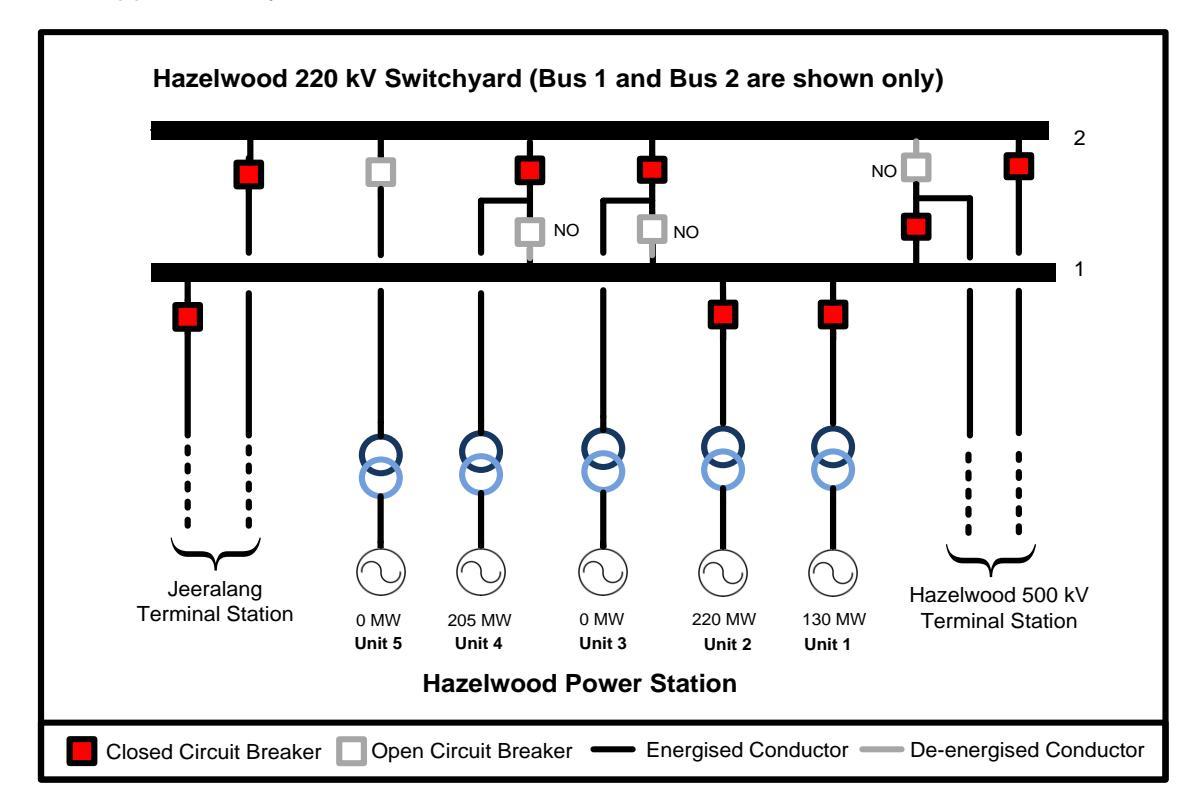
The status of the relevant power system equipment before the incident is shown in Figure 1. Prior to the incident, Hazelwood Power Station generating unit 1 was generating approximately 130 MW and unit 2 approximately 220 MW.

Figure 1 - Status of relevant circuit breakers, generating units and conductors prior to the event – "NO" donates a normally open circuit breaker

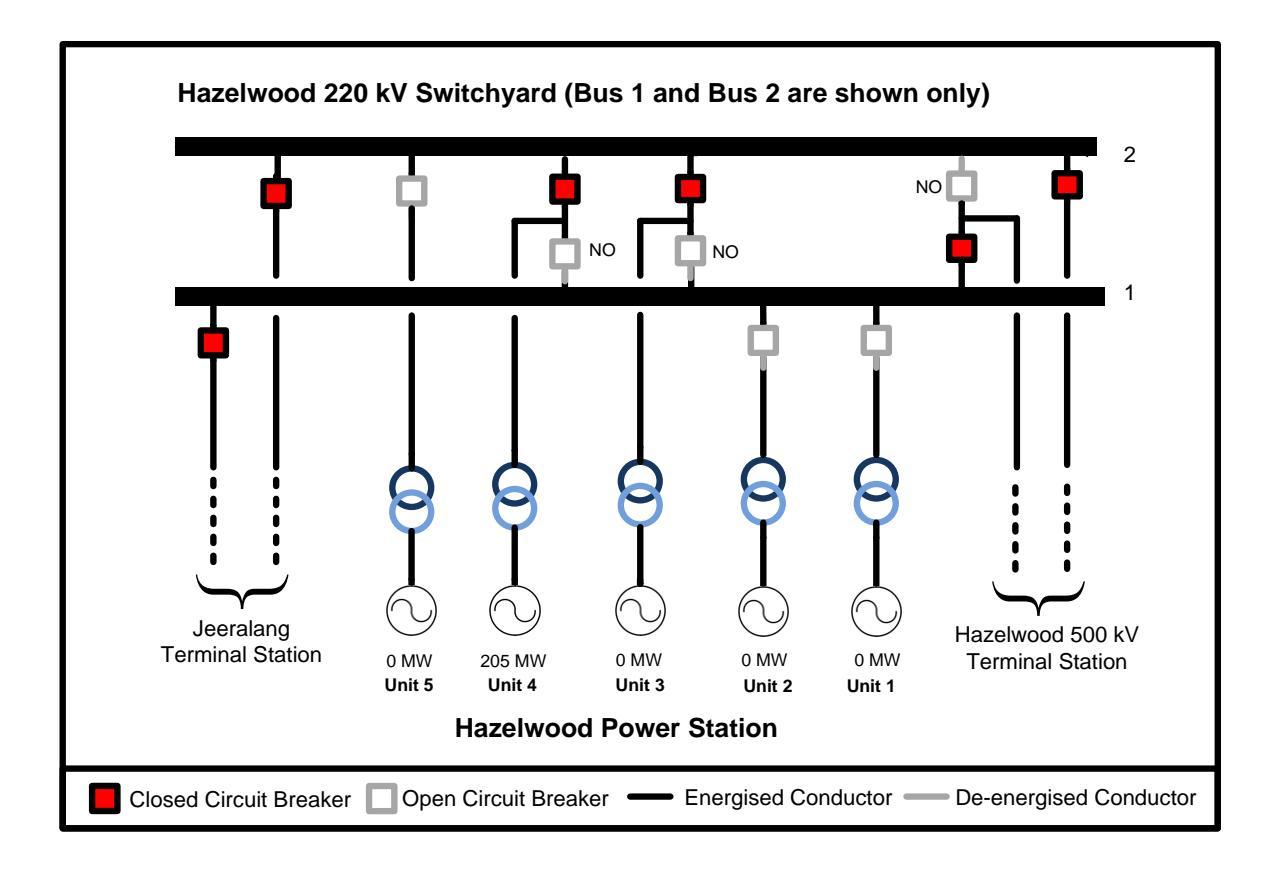
Figure 2 shows the status of the relevant circuit breakers, generating units and conductors following the operation of generating units 1 and 2 protection systems.

Figure 2 - Status of relevant circuit breakers, generating units and conductors after the event - "NO" donates a normally open circuit breaker
