POWER SYSTEM OPERATING INCIDENT REPORT – MULTIPLE CONTINGENCY EVENT FOLLOWING AN EARTHQUAKE IN VICTORIA ON 19 JUNE 2012 – FCAS REVIEW

PREPARED BY: Systems Capability

DATE: 15 January 2013

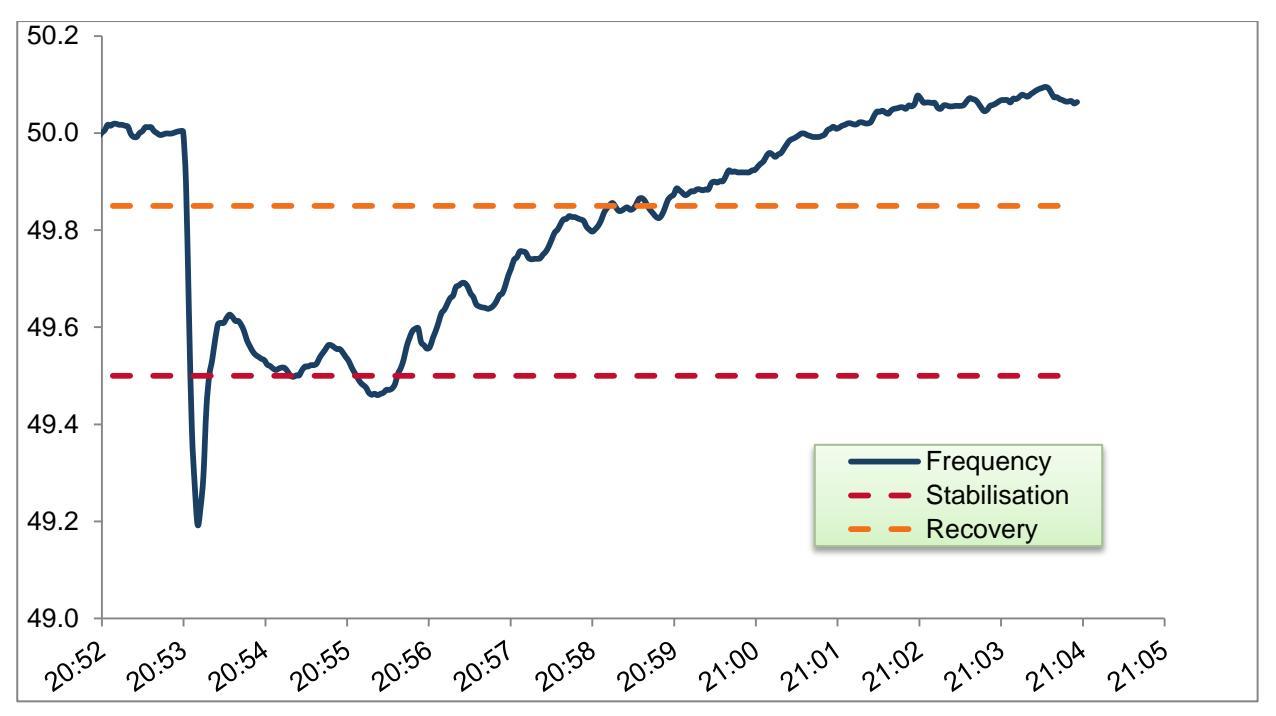
Figure 1 Mainland frequency on 19 June 2012

The power system frequency in the Mainland fell to a minimum of 49.2 Hz at 20:53:54 hrs. The power system responded to bring the system frequency back within the stabilisation lower limit in approximately 14 seconds. However, the system frequency fell below the stabilisation lower limit again after 122 seconds which is in violation of the Mainland FOS.

The frequency returned and remained in the stabilisation band after 146 seconds and returned within the recovery band lower limit within 245 seconds. The recovery criteria of the Mainland FOS were met.

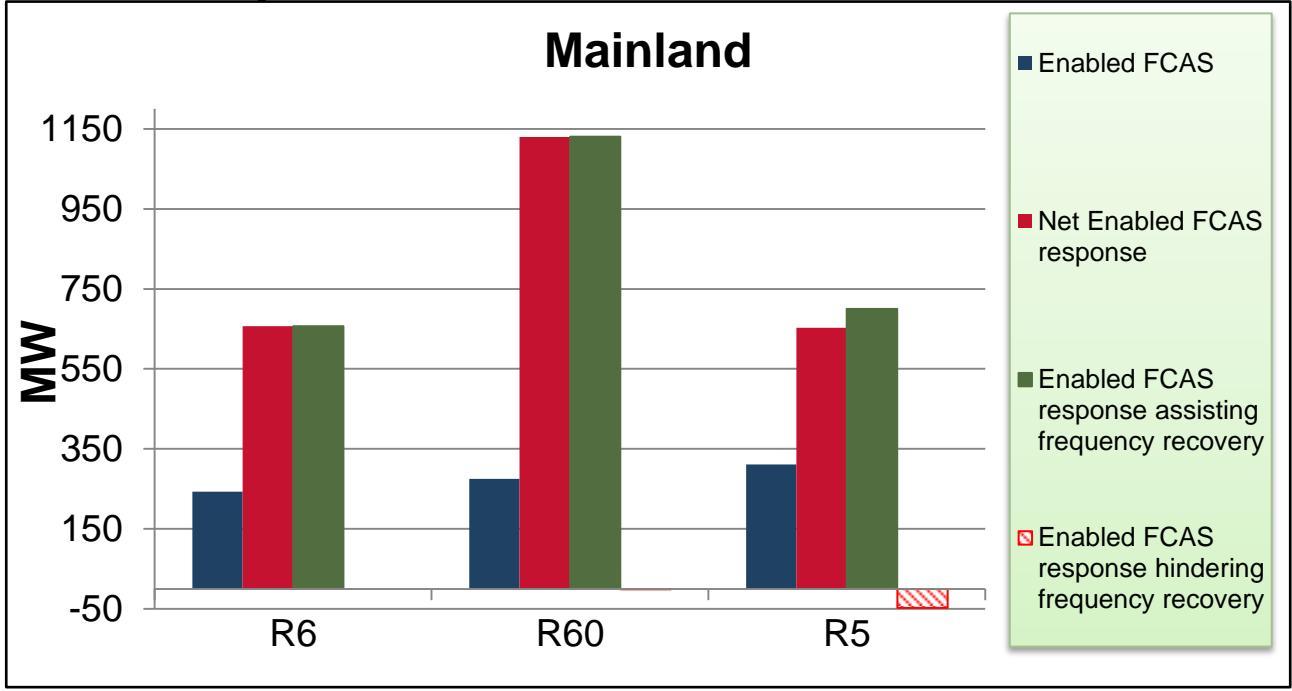
Figure 2 Mainland FCAS raise service from enabled units

In addition to the enabled units above, the following was also delivered from units not enabled for raise FCAS:³

- 32.1 MW of slow raise FCAS (R60)
- 349.2 MW of delayed raise FCAS (R5)

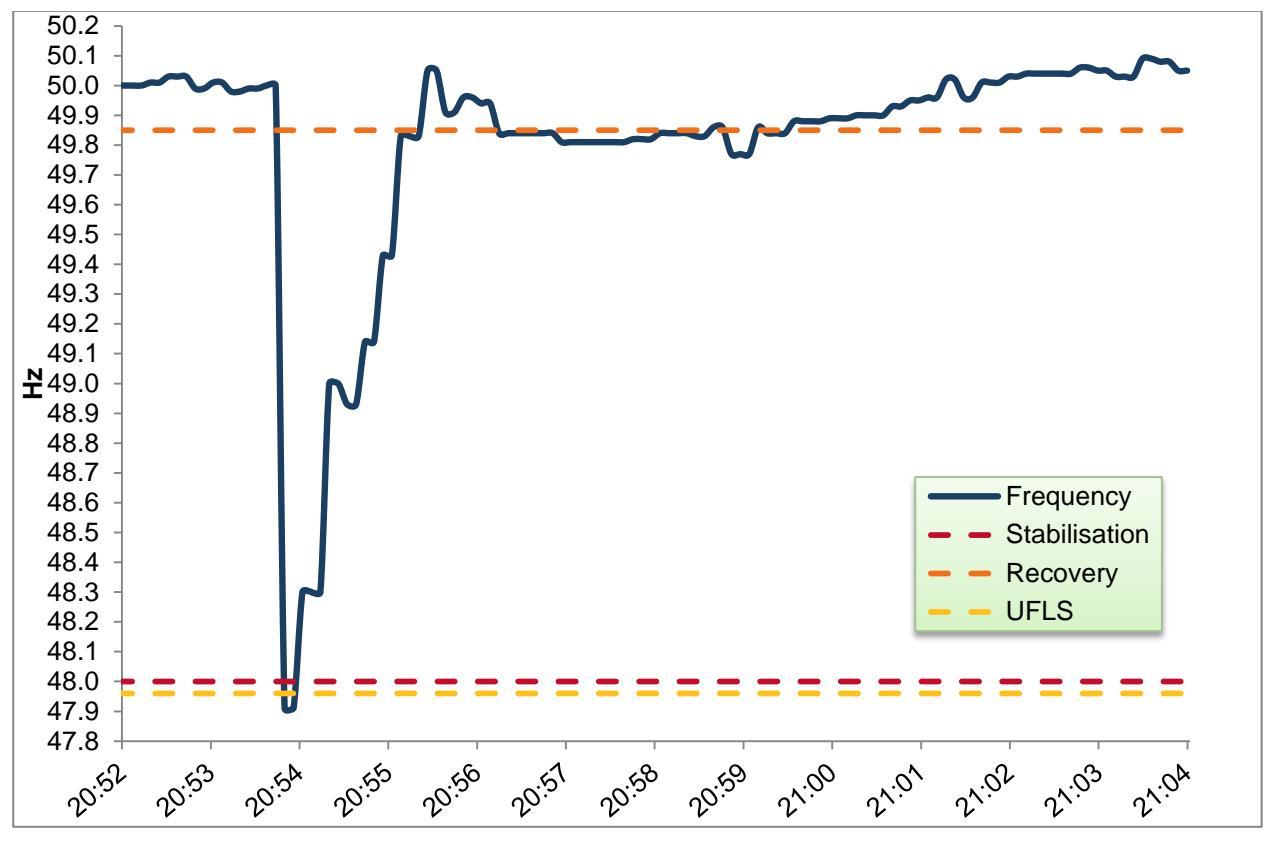
Figure 3 Tasmania frequency on 19 June 2012

The loss of approximately 1955 MW from the Mainland resulted in a drop in Mainland frequency. The Basslink frequency controller responded as expected to increase the export from Tasmania from approximately 130 MW to 580 MW into Victoria. This resulted in a frequency excursion in the Tasmanian frequency from 49.99 to 47.95 Hz.

The minimum frequency experienced at 20:53:47 hrs crossed the threshold for the Tasmania UFLS which is set to trigger at 47.96 Hz resulting in the shedding of 200 MW of major industrial

load. Frequency recovered to within the stabilisation band within 0.2 minutes and to within the recovery band within 5.7 minutes. The Tasmania region frequency operating standard was met for this event.

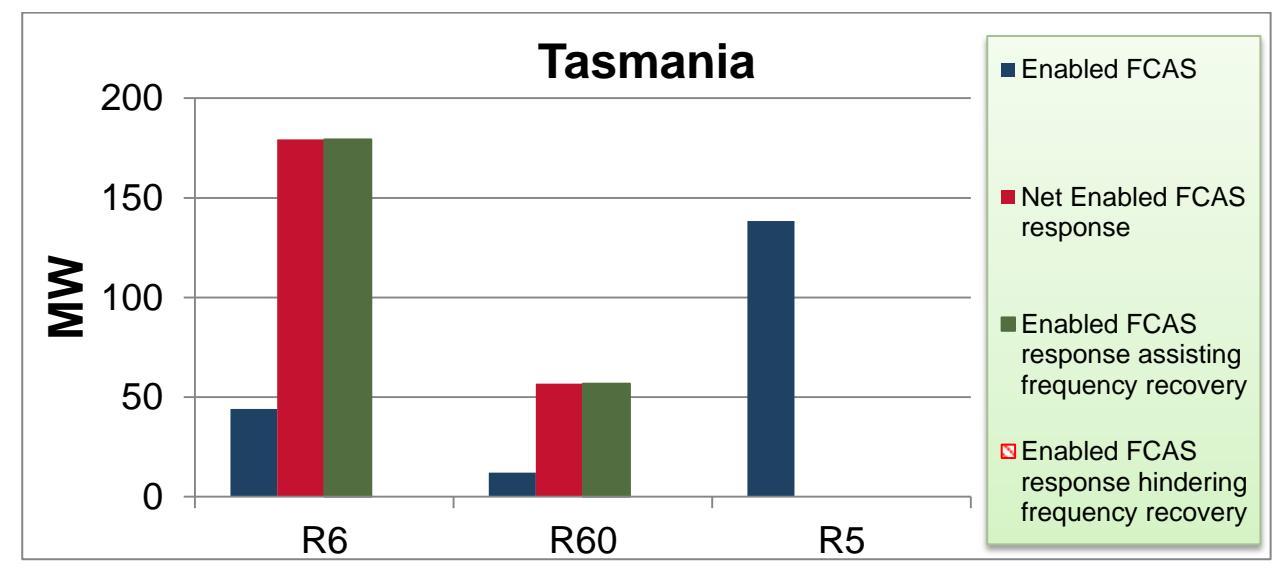
Figure 4 Tasmania FCAS raise service from enabled units

In addition to the enabled units, 322.2 MW of slow raise FCAS (R60) was also delivered from units not enabled for raise FCAS.
