# POWER SYSTEM INCIDENT REPORT: TROPICAL CYCLONE YASI – 02 AND 03 FEBRUARY 2011

PREPARED BY: Electricity System Operations Planning and Performance

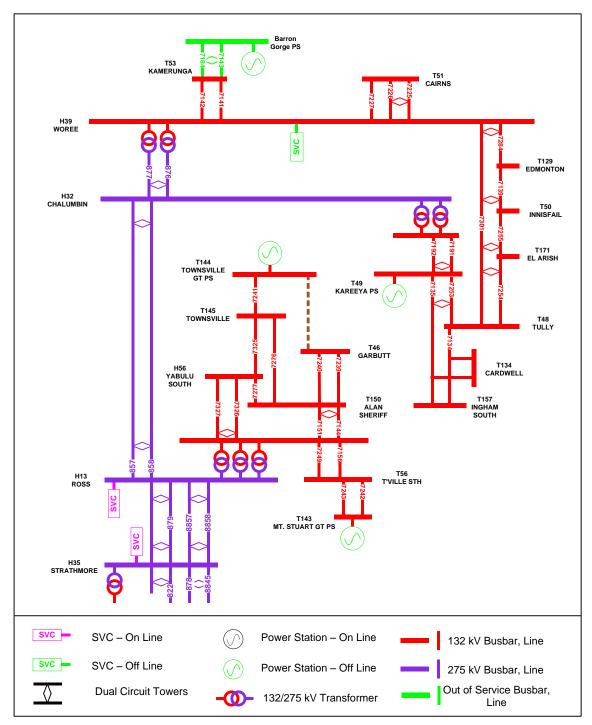
The status of the north Queensland power system immediately prior to the TC Yasi crossing the coast is shown in Figure 1.

Figure 1 - North Queensland high voltage transmission network prior to the arrival of TC Yasi

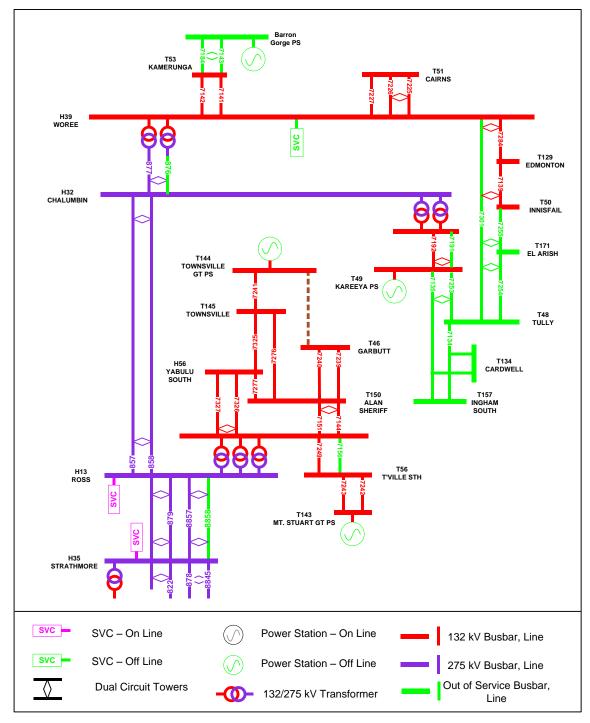
The status of the north Queensland power system immediately after TC Yasi crossed the coast is shown in Figure 2.

Figure 2 - North Queensland high voltage transmission network after the arrival of TC Yasi

As a result of damage wrought by the cyclone twelve 132 kV transmission lines tripped out of service, and four bulk supply 132 kV substations and one power station were automatically disconnected from the power system. The sequence of events on the transmission network associated with crossing of TC Yasi can be seen in Table 1 of Appendix A.

The following 132 kV transmission lines were disconnected from the power system due to damage caused by TC Yasi:

- No.7135 Kareeya Ingham South Tee Cardwell 132 kV line (two transmission lines)
- No.7143 Barron Gorge Kamerunga 132 kV line
- No.7184 Barron Gorge Kamerunga 132 kV line
- No.7134 Tully Ingham South Tee Cardwell 132 kV line (two transmission lines)
- No.7254 Tully El Arish 132 kV line
- No.7255 Innisfail El Arish 132 kV line
- No.7301 Woree Tully 132 kV line
- No.7253 Kareeya Tully 132 kV line
- No.7191 Kareeya Chalumbin 132 kV line
- No.7156 Ross Townsville South 132 kV line

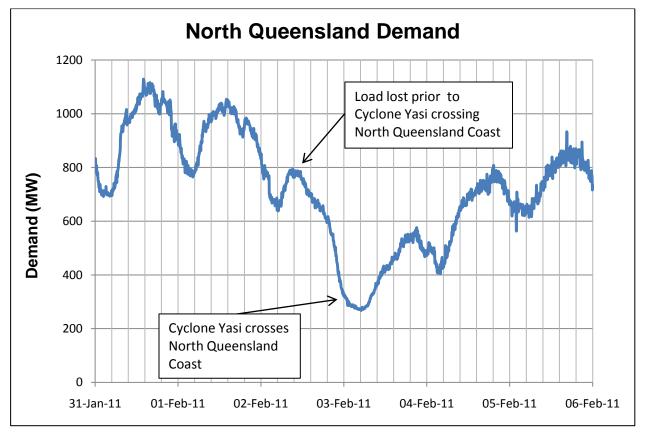
The reduction of load in north Queensland while TC Yasi was active is illustrated in Figure 3. As shownFigure 3, the majority of load was reduced prior to the cyclone crossing the north Queensland coast, due to interruptions caused by damage to the distribution network as the cyclone approached the coast and due to customers pre-emptively reducing demand, closing businesses and evacuating residences.

Figure 3 – North Queensland power system demand prior, during and after the crossing of TC Yasi

During the incident the 275 kV transmission network in north Queensland experienced higher than normal voltage levels. The high voltage was caused by the reduced demand in north Queensland, through customers switching off loads, load being interrupted due to damage to the distribution network, and the deactivation of the Woree 132 kV SVC. In order to ensure that the voltage on the
