Hazelwood – Cranbourne No. 4 500 kV line trip at the Hazelwood end only on 2 March 2022

June 2022

Reviewable Operating Incident
Report under the National
Electricity Rules

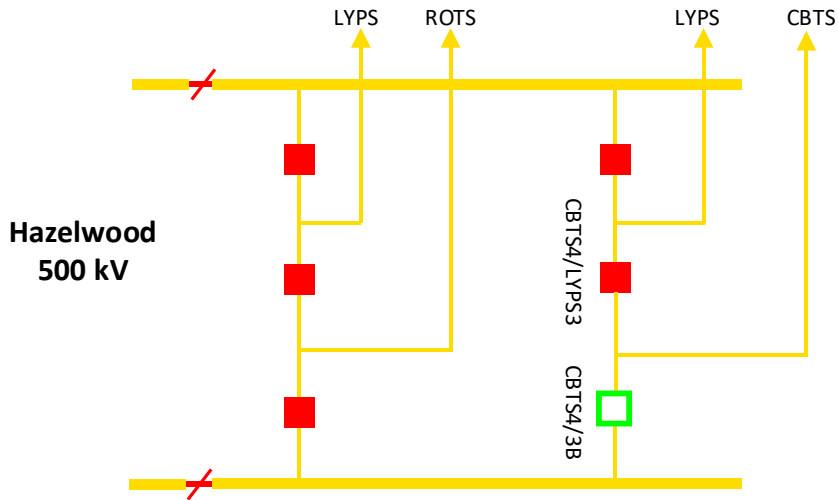
Figure 1 Incident diagram – system prior to the trip of LYPS3/CBTS4 500 kV CB

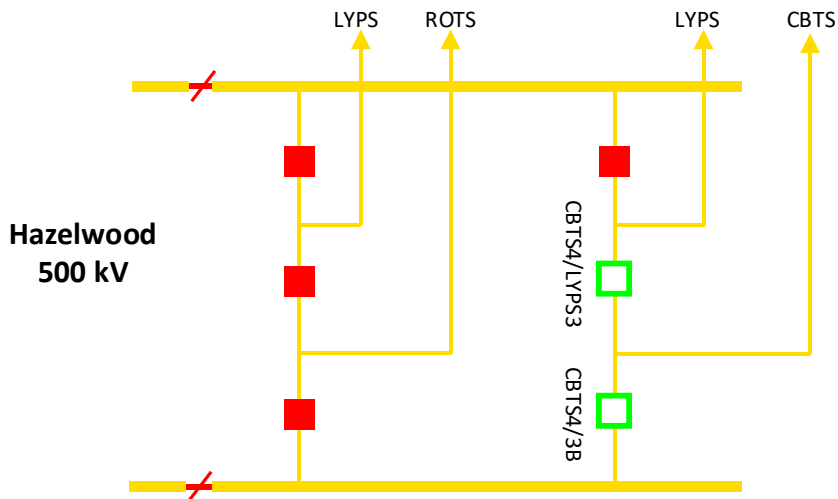
Figure 2 Incident diagram - system following the trip of LYPS3/CBTS4 500 kV CB
