Trip of Robertstown – Tungkillo 275 kV No. 1 line at the Tungkillo end only and the Robertstown No. 1 and No. 2 Synchronous Condensers on 28 November 2023

May 2024

Reviewable Operating Incident
Report under the National
Electricity Rules

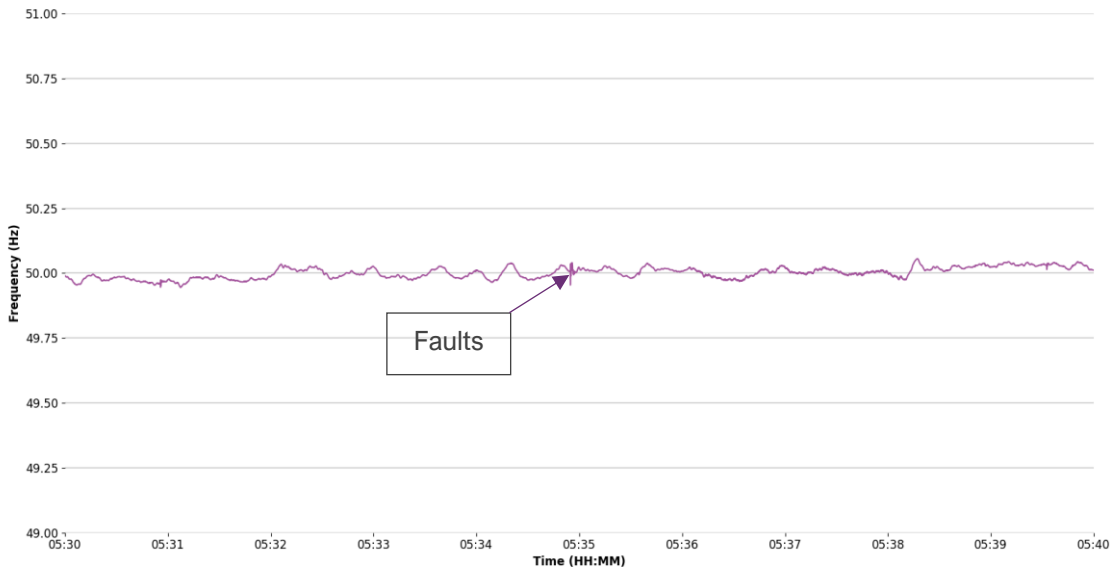
Figure 1 South Australia frequency on 28 November 2023

As shown below in Figure 1, as a result of the non-credible contingency at 05:34 hrs, the system frequency reached a minimum of 49.95 hertz (Hz). The frequency did not leave the normal operating frequency band throughout the incident. The power system remained in a secure operating state throughout this incident and the Frequency Operating Standard (FOS)¹³ was met throughout this incident.

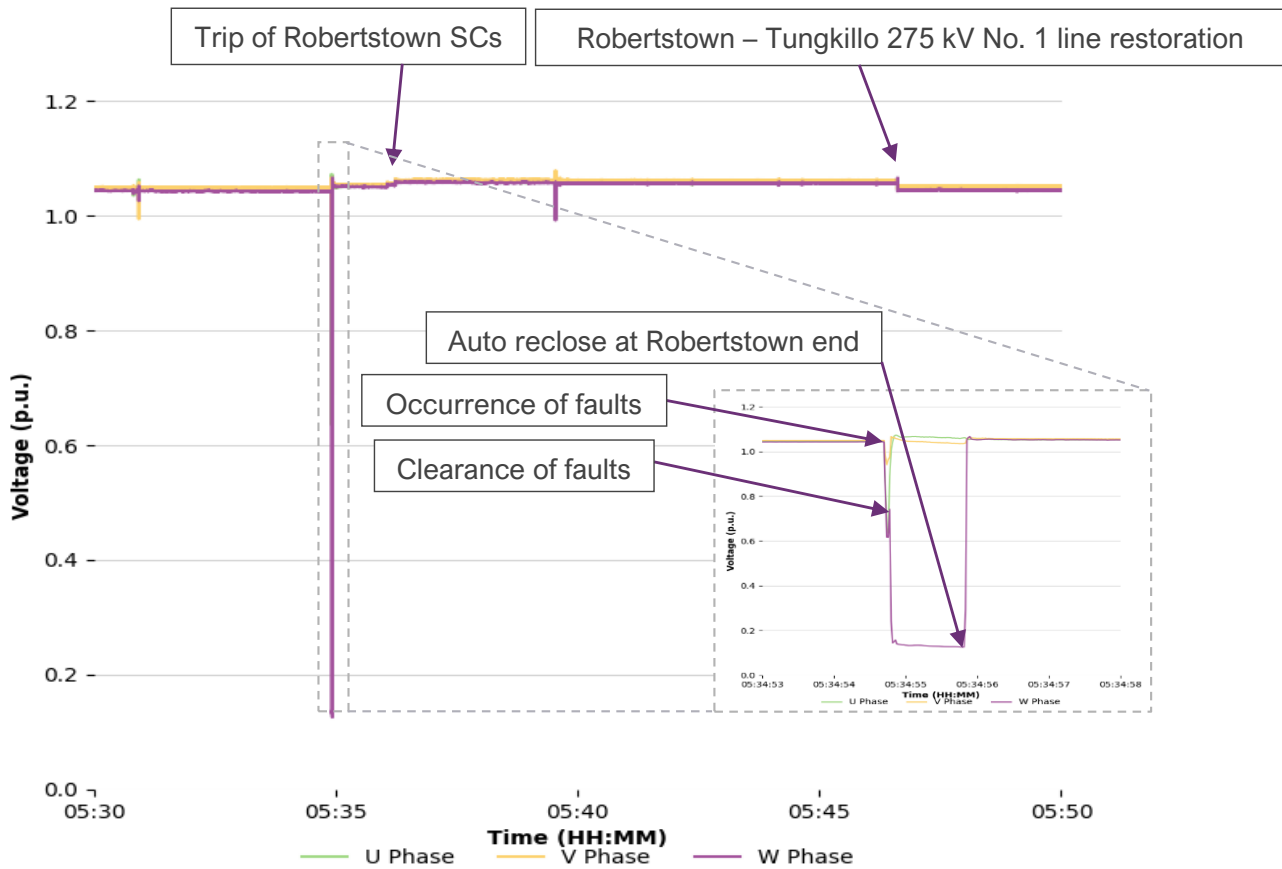
Figure 2 Voltage at Tungkillo 275 kV busbar of the Robertstown – Tungkillo 275 kV No. 1 line on 28 November 2023 – high speed monitoring data

At no point during this incident were transmission system voltages outside of relevant voltage limits defined in the NER, or as specified by Network Service Providers (NSPs) in their limits advice to AEMO. Figure 2 shows the voltage at Tungkillio 275 kV busbar of the Robertstown – Tungkillio 275 kV No. 1 line on 28 November 2023 as recorded by high-speed monitoring systems. Figure 2 shows that voltage at Tungkillio 275 kV bus slightly increased around 05:36 hrs following the trip of Robertstown No. 1 and Robertstown No. 2 SCs. The voltage comes slightly down to the pre-contingent level following the restoration of Robertstown – Tungkillio 275kV No. 1 line.

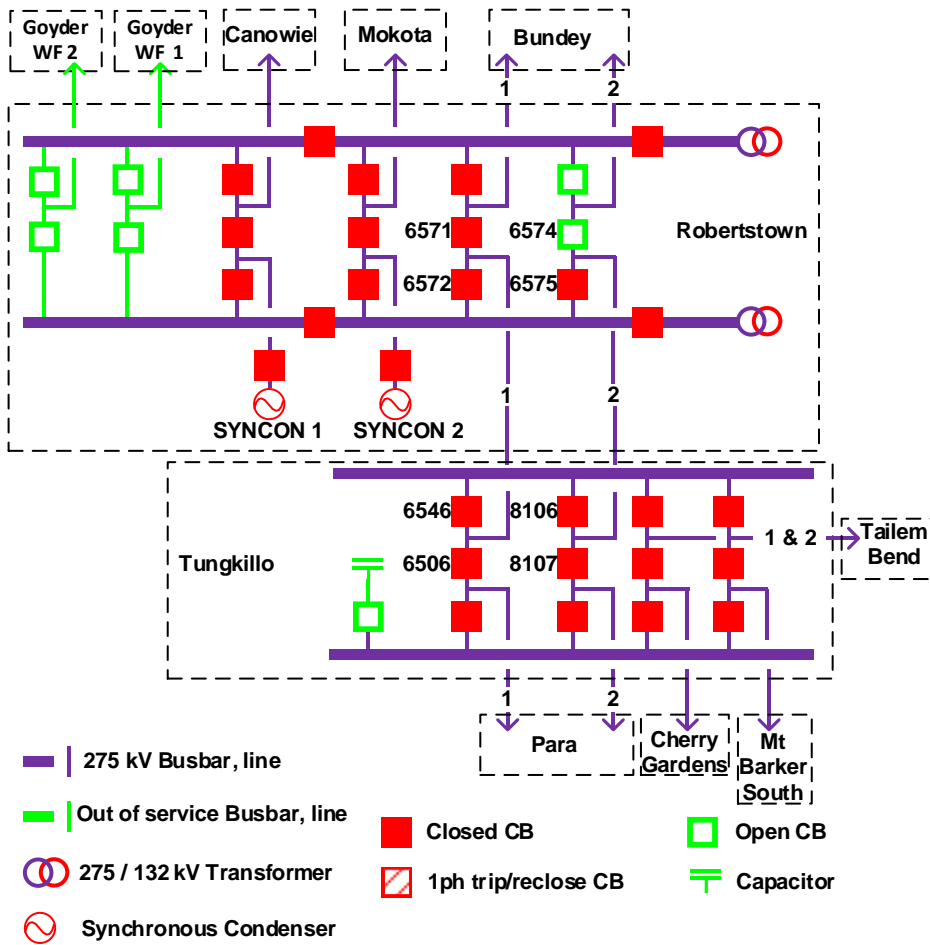
Figure 3 Pre-incident network diagram

Figure 3 provides an overview of the key transmission elements relevant to the event immediately prior to the incident.

Prior to the incident at 05:34 hrs, all circuits were in service at Tungkillo 275 kV substation. Only CB 8128 and 8129 for future Goyder wind farm, CB 8127 and 8126 for future Goyder wind farm 2, and CB 6574 and 6573 for future Bunday 2 line were on planned outages at Robertstown 275 kV substation (see Figure 3).

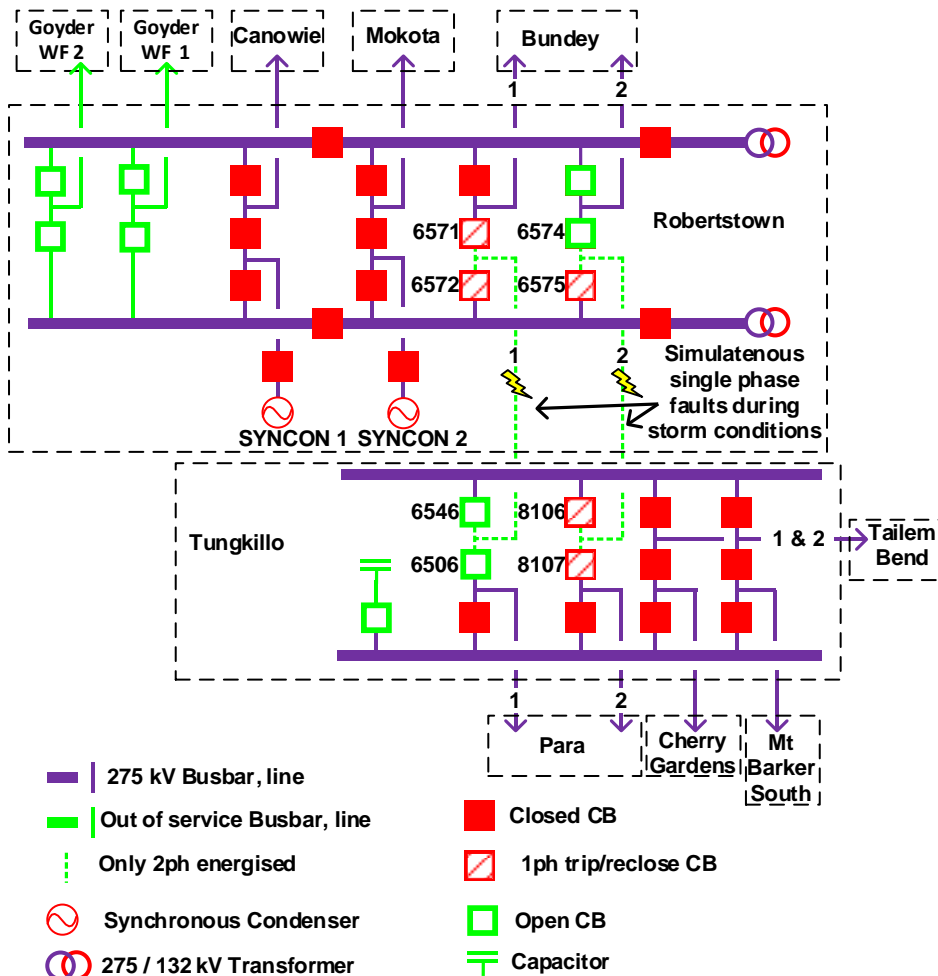
Figure 4 Network diagram immediately following the trip of Robertstown – Tungkillo 275 kV No. 1 line and SPAR of No. 2 line

Figure 4 provides an overview of the key transmission elements relevant to the event immediately after the trip of Robertstown – Tungkillo 275 kV No. 1 and No. 2 lines at approximately 05:34:55 hrs.

As such, the W phase of CB 6571 and 6572 at Robertstown tripped to clear the fault and the W phase of the same CBs successfully auto reclosed within 1 second (s). All three phases of CBs 6506 and 6546 at Tungkillio tripped and locked out to clear the fault (see Figure 4).

Tungkillio end	
Set X protection	Differential trip, resulted in trip of W phase
Set Y protection	Phase Distance Zone 2 – Blocking scheme trip, resulted in trip of all three phases
Fault clearance time	78.4 ms
Fault distance from substation	101.11 km
Result	Three phase tripping of 6506 and 6546 CBs (see Figure 4)
Robertstown end	
Set 1 protection	Differential trip, trip of W phase
Set 2 protection	Earth Distance Zone 1 trip, resulted in trip of W phase
Fault clearance time	67.6 ms
Fault distance from substation	5.45 km
Result	Trip and reclose of W phase of 6571 and 6572 CBs (see Figure 4)

Tungkillio end	
Set 1 protection	Differential trip, resulted in trip of U phase
Set 2 protection	Differential trip, resulted in trip of U phase
Fault clearance time	55.4 ms
Fault distance from substation	100.13 km
Result	Trip and reclose of U phase of 6571 and 6572 CBs (see Figure 4Figure 4)
Robertstown end	
Set 1 protection	Differential trip, resulted in trip of U phase
Set 2 protection	Differential trip, resulted in trip of U phase
Fault clearance time	55.1 ms
Fault distance from substation	6.46 km
Result	Trip and reclose of U phase of 6575 CB (see Figure 4Figure 4)

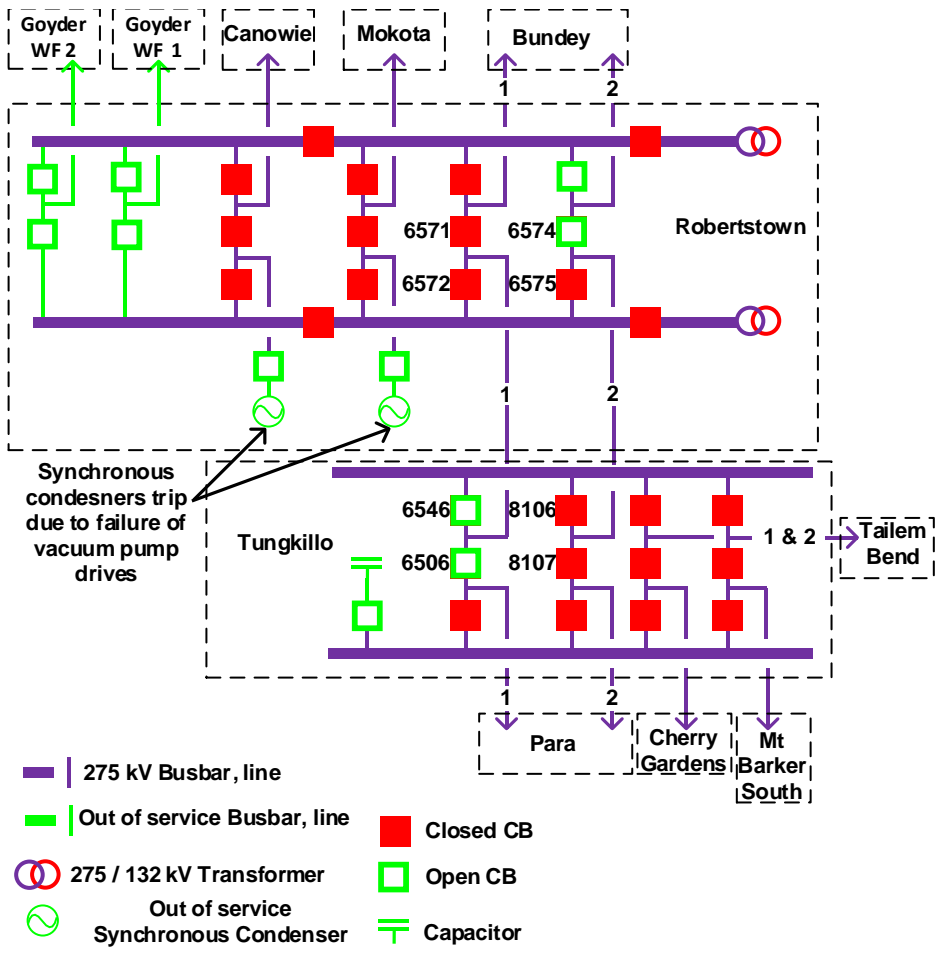
Figure 5 Network diagram immediately following the trip of Robertstown SCs

Figure 5 provides an overview of the key transmission elements relevant to the event immediately after the trip of the Robertstown SCs at approximately 05:36:05 hrs.

Associated with this event, Robertstown No. 1 and No. 2 SCs tripped at 05:36:04 hrs and 05:36:13 hrs respectively (see Figure 5). The trip condition opened the 15.75 kV machine CBs, leaving the SC step up transformers energised. Upon further investigation, ElectraNet determined that the tripping was due to the failure of each SC's flywheel housing vacuum pump drive.
