# Trip of Multiple Transmission Elements at Ross Substation on 22 May 2018

Reviewable operating incident report under the  
National Electricity Rules

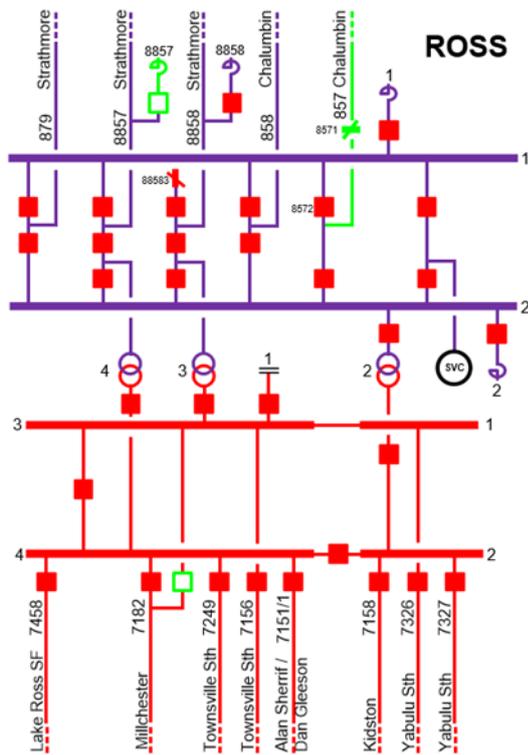
**Before**

The diagrams below show the status of switchgear at Ross substation before and immediately after this incident.
