Trip of the Farrell – John Butters
and Farrell – Roseberry – Newton –
Queenstown lines on 28 May and
21 August 2019

December 2019

Reviewable Operating Incident Report under the
National Electricity Rules

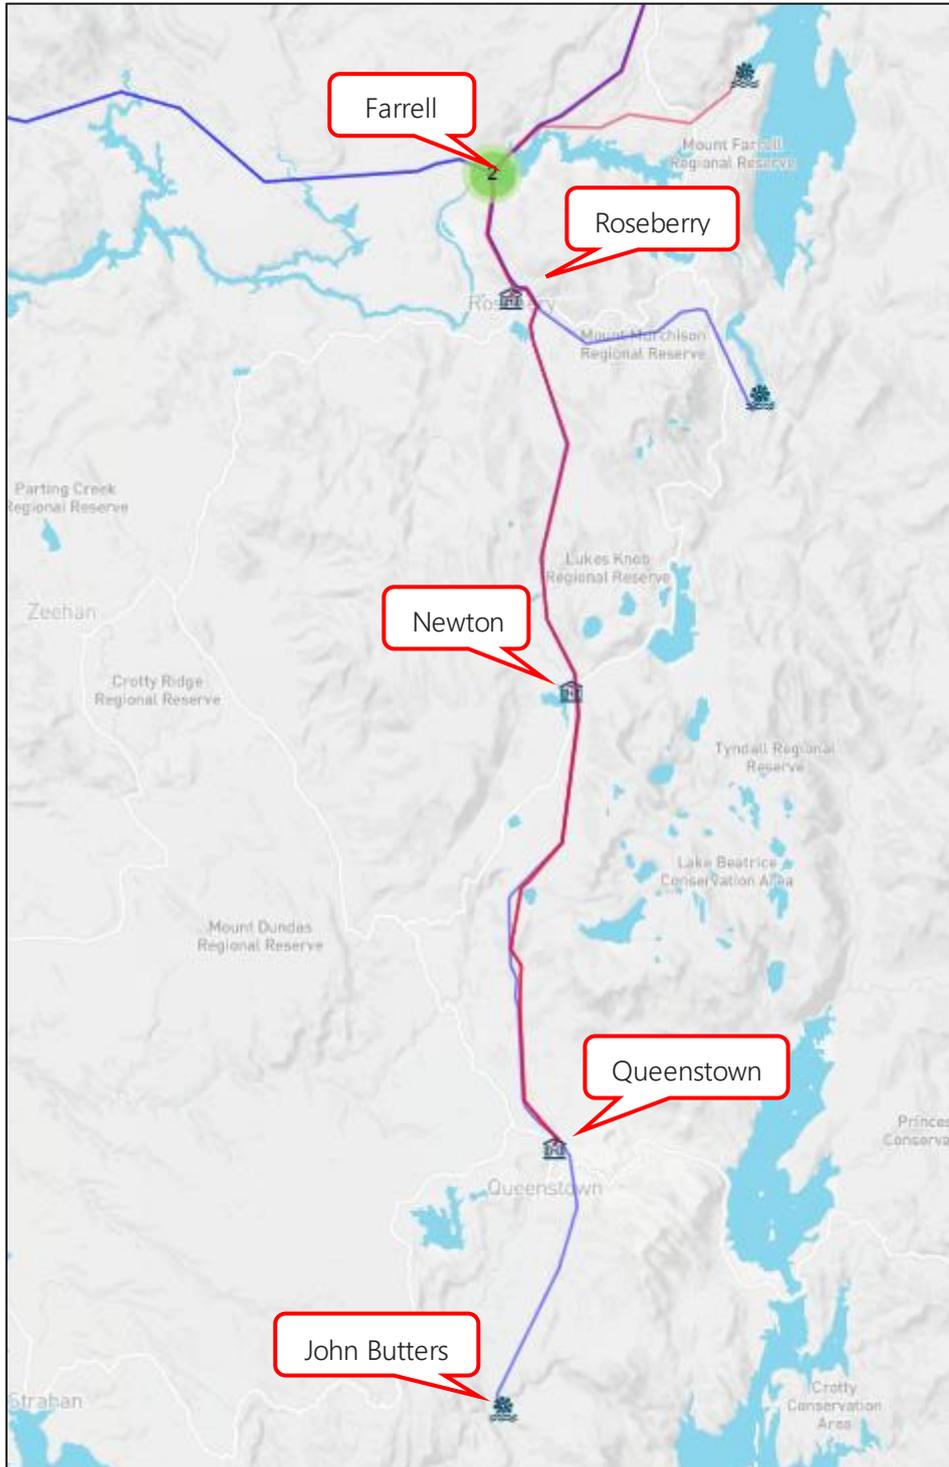
A1. Geographic overview

The diagram below shows the geographic relationship between the FA-JB line (in blue) and the FA-RB-NT-QT line (in red).
