# Trip of Ross – Chalumbin 857 and 858 feeders on 25 January 2020

Reviewable Operating Incident Report under the  
National Electricity Rules

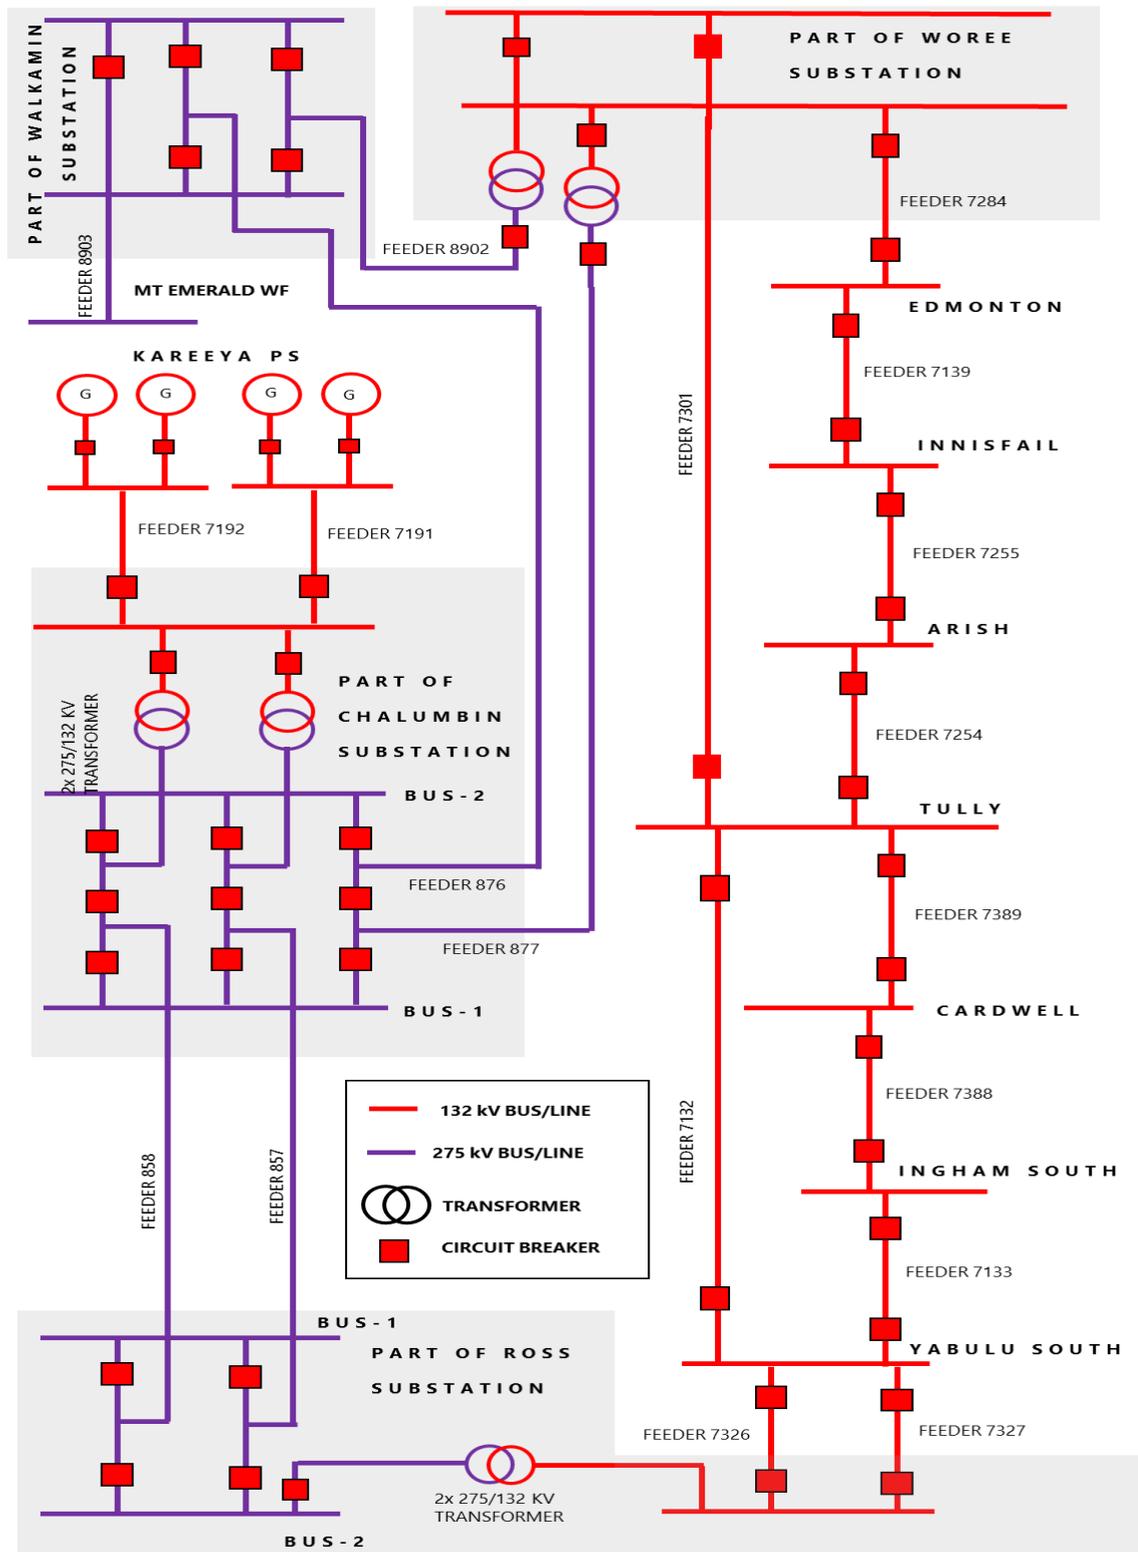
Figure 1 Single line diagram of the part of the North Queensland power system immediately prior to the incident discussed in this report.
